Erken Osmanlı Dönemi Cami Mimarisi Bağlamında Bursa Ulu Camii, Orhan Camii ve Yeşil Camii'nin Koruma ve Restorasyon Süreçlerinin Değerlendirilmesi

Evaluation of the Conservation and Restoration Processes of Bursa Grand Mosque, Orhan Mosque, and Green Mosque within the Context of Early Ottoman Mosque Architecture

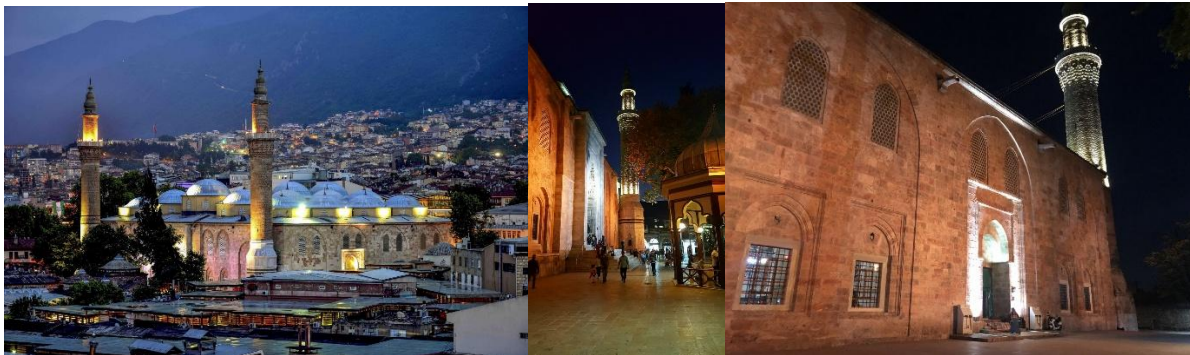
Photo 1. Exterior view of Bursa Grand Mosque

The building has a rectangular plan measuring 60 × 48 meters. The walls, built of yellowish limestone (küfeki stone), exceed two meters in thickness at specific points. The plan scheme follows the Seljuk multi-pier mosque tradition, with twelve piers connected by pointed arches. The load of the twenty domes is transferred to the foundation through octagonal drums and pointed arches.

Throughout history, the Bursa Grand Mosque has undergone numerous restorations following natural disasters and fires. The 1855 Bursa earthquake caused severe structural damage, leading to the reconstruction and repair of domes, arches, and minarets (Yurtseven, 2020).

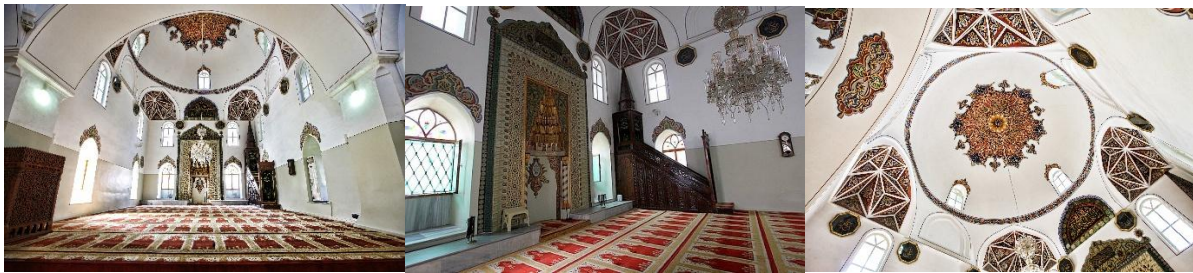
Inside, plaster decorations adorn the pendentives, drum zones, and wall surfaces. The mihrab, executed in malakari technique, displays stalactite motifs arranged in seven tiers and refined rumi ornaments, reflecting the elegant decoration style of the 14th century. Painted ornaments and stained-glass windows enrich the spatial atmosphere (Aydın, 2017).

Photo 4. Interior View of the Orhan Mosque, Bursa

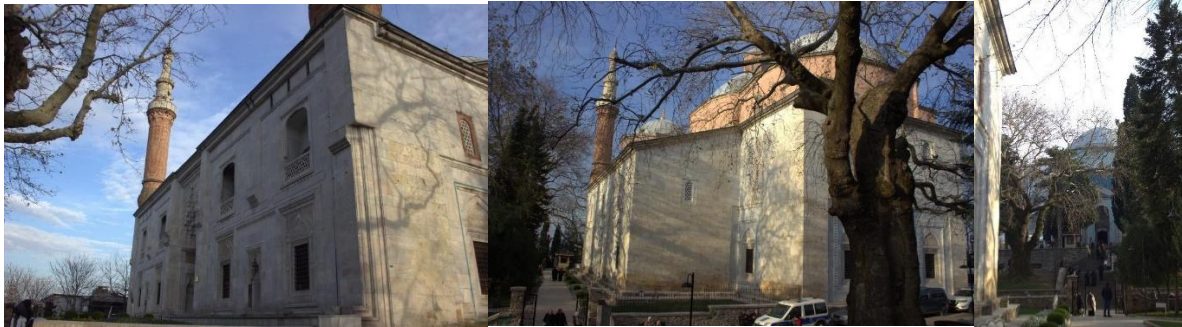
The building follows a reversed T-plan typology. From the entrance hall, access is provided to two symmetrical iwans, leading to the tabhane (guest rooms) and the upper royal loge (hünkâr mahfili). The upper loge, modeled on a small pavilion, reflects the reception culture of the Ottoman court during the early 15th century (Atan Bülbül).

Photo 5. Exterior View of the Yeşil Mosque, Bursa

The mosque sustained considerable damage during the 1855 earthquake, particularly in its minarets, which were later reconstructed to reflect the 19th-century stylistic characteristics. During the rebuilding process, the shafts were constructed of brick, while the upper parts were made of stone masonry (Kul, 2021). The construction of the mosque began in 1414 and, according to its inscription, was completed in 1419. The monumental portal, adorned with muqarnas details, intricate marble craftsmanship, and elaborate calligraphic compositions, represents one of the most distinguished examples of early Ottoman stone decoration (Atan Bülbül).

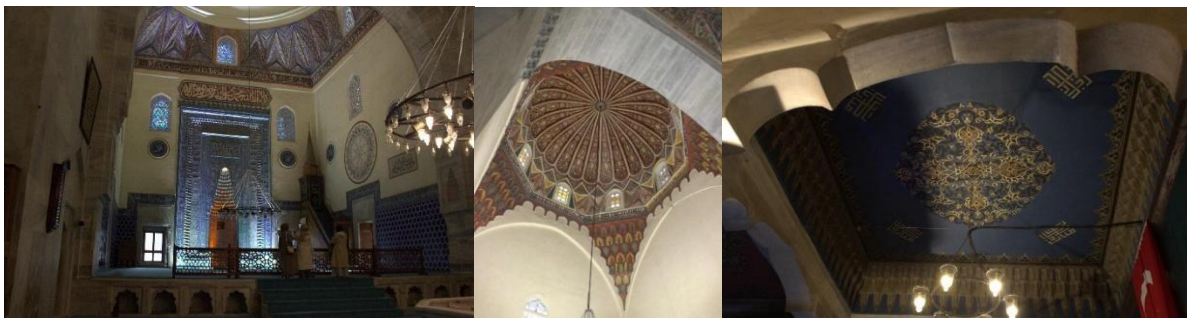
The interior decoration of the mosque exhibits a rich synthesis of tile, wood, plaster, and painted ornamentation. The mihrab is entirely covered with tiles produced using the colored-glaze (cuerda seca) technique, framed by seven differently sized borders (Yıldırım, 2007, p.166). The stucco and tile decorations within the tabhane rooms are characterized by rûmî and hatâyî motifs arranged in intricate compositions (Terzi Doğan, 2010).

The painted decorations (kalemişi) are particularly concentrated around the iwans and drum sections. These were renewed during 18th-century restorations with Western-influenced motifs, while specific original examples were unfortunately lost during the 2010 restoration campaign (İrteş, 2021, pp.73–79). Some details from the recent interventions do not correspond to the Parvillee drawings, suggesting that additional structural modifications were introduced over time (Budak, 2017).

Photo 6. Interior View of the Yeşil Mosque, Bursa
